REPORT

Master Drainage Plan Update 2021 Drainage Report

Sayward, BC

Report No. 4313.01

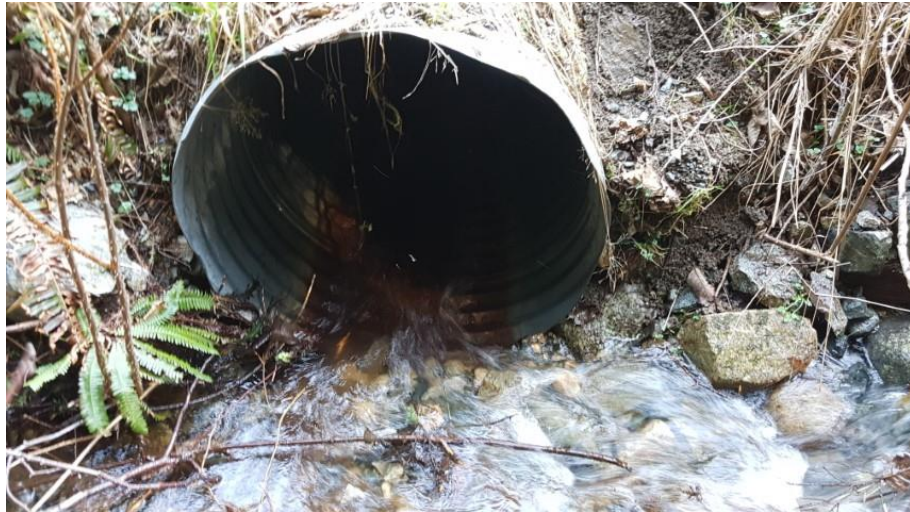
Creek 3A, 3B and 3C cross M-Branch in steel culverts which appear to be clear and in good condition (**Photo 1 & Photo 2**). Gravels were observed being easily transported through culvert 3C without any blockages.

Photo 1 - Culvert inlet at Creek 3C crossing of M-Branch

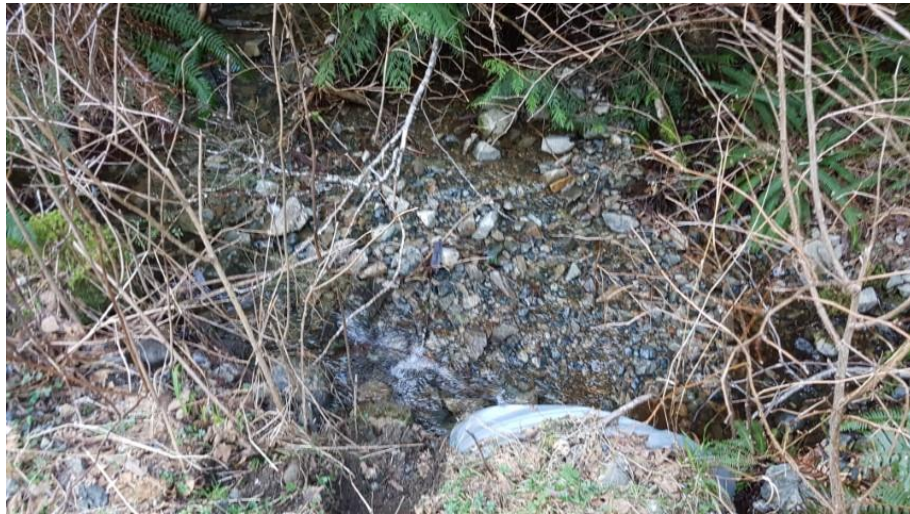
Photo 2 - Culvert outlet at Creek 3C crossing of M-Branch

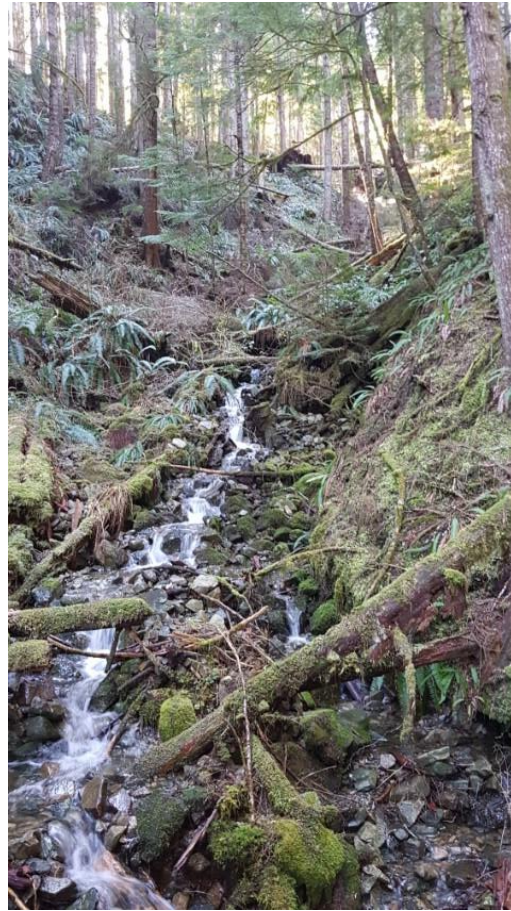
Creek 3C below M-Branch consists of a gully between 2m and 15m deep with continuous gravel and cobbles in the creek bed. There are many areas of bank sloughing and / or undercutting, where gravelly till is exposed up to ~3m height. The side slopes of the gullies are wet and loose, and any fallen trees expose the gravelly subsoils. See photos **Photo 3** and **Photo 4**.

Photo 3 - Creek 3C gully just below M-Branch road crossing. Note gravel and cobbles in creek bed.

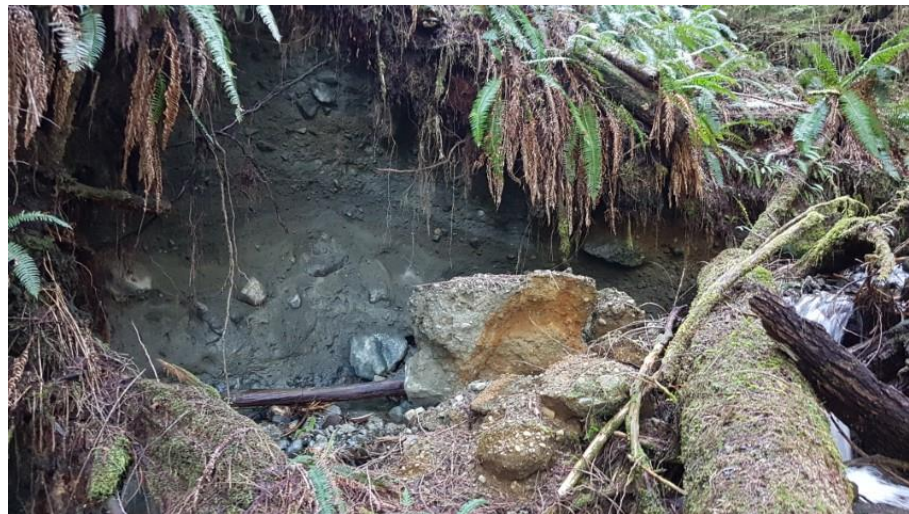
Photo 4 - Undercut bank in mid-section of Creek 3C with exposed gravelly subsoils

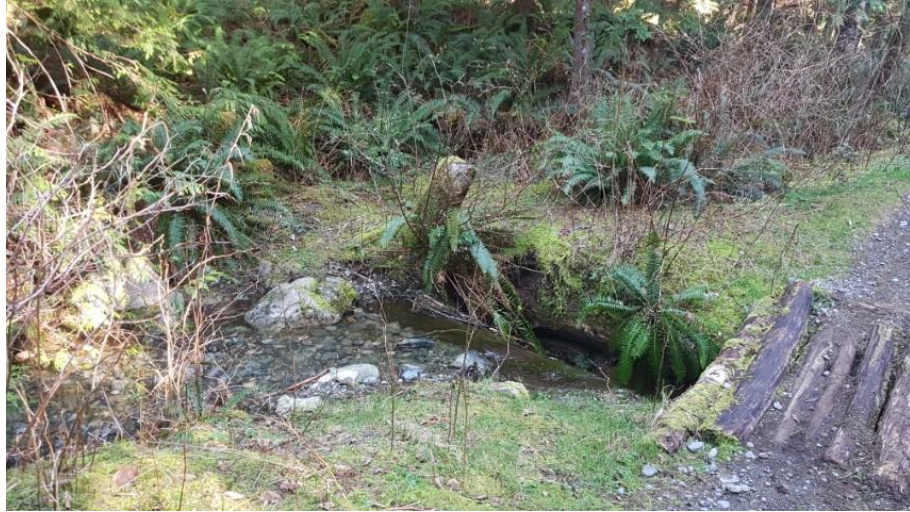
The interceptor ditch runs across slope, on the uphill side of an existing trail (Dyer Drive access trail), to a wooden log diversion structure at elevation ~27m (**Photo 5**). Flows are directed downslope into a drainage channel that is eroded (up to 2m deep) by water flow, has substantial amounts of exposed gravelly subsoils in the banks and continues to be eroded by water flow (**Photo 6**).

Photo 5 - Wooden log diversion structure for Creek 3A & 3B flows (water flows left to right under the trail)

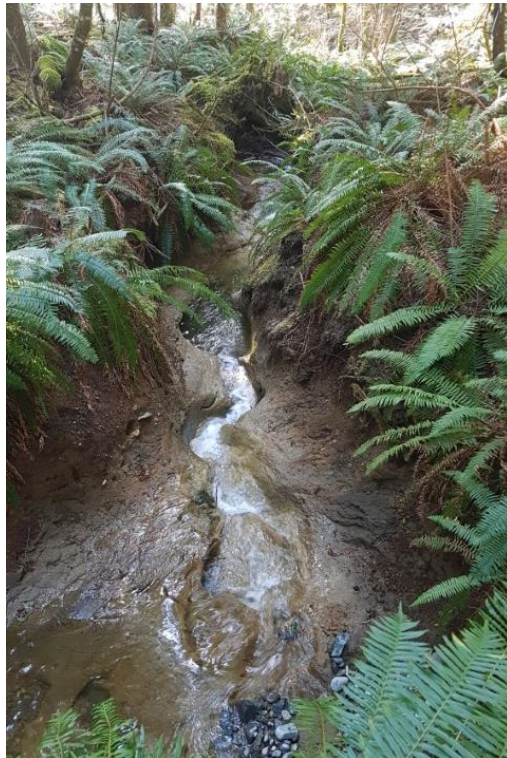
*Photo 6 - Creek 3A & 3B drainage channel below wooden log diversion structure.
Note exposed gravels in walls and continued erosion in bottom of channel*

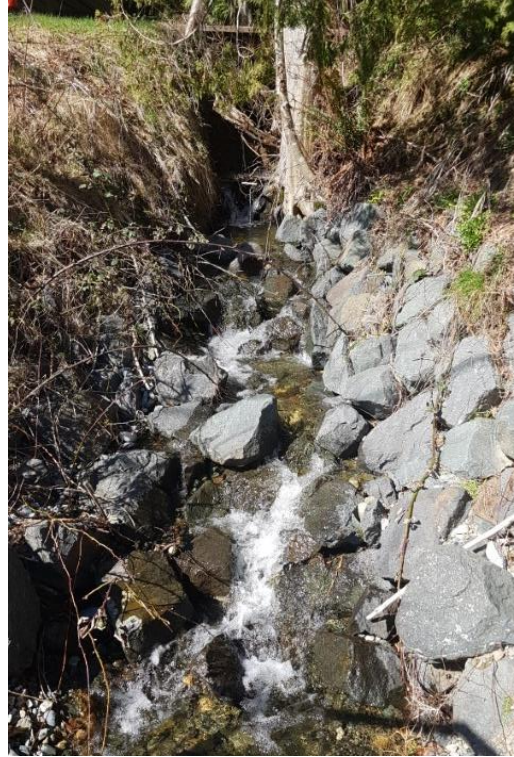
This channel runs down along the property line of 290/300 MacMillan Drive (channel is riprap lined at this point - **Photo 7**) to a recently installed 600 mm diameter concrete headwall in the MacMillan Drive right of way. The 600 mm pipe extends to a catch basin structure that has been overbuilt on 600 mm CSP culvert pipe running parallel with the roadway. This is the location where flooding described in **Section 2.5.1** is originating.

Photo 7 - Drainage ditch upstream of Headwall 1

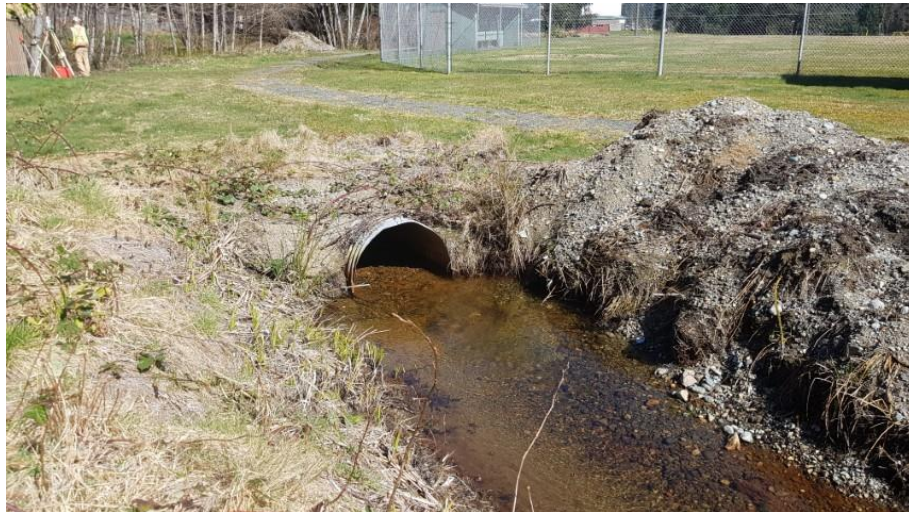
From here, underground pipes take the flow northwest on MacMillan Drive and then south-east down through the west side of a vacant lot (301 MacMillan Drive) to outlet in a ditch in H'Kusum Park (**Photo 8**) at elevation ~3.9 m. No easement or SRWs are registered over the pipe route through 301 MacMillan Drive to allow the Village legal access for maintenance or replacement of the pipe. There is a bend in the pipe at the H'Kusum Park property line, however Highland did not locate any manhole structure here and no manhole is shown on the utility mapping. We did note bubbling of water up through the ground at the entrance to H'Kusum Park. This indicates that the existing 900 mm CSP pipe is being surcharged and water is flowing out of failed joints or corroded areas of pipe.

During the January site visit, Highland observed gravel in the Creek 3A / 3B outlet pipe in H'Kusum Park almost up to the top of pipe, and gravel to the same elevation in the ditch. **Photo 8**, taken in

March 2021, shows that Village crews have since dredged this channel to remove gravel down to approximately halfway up the pipe.

Photo 8 - Creek 3A & 3B outlet in H'Kusum Park. Note gravel depth in pipe and ditch, and pile of dredged material next to ditch.

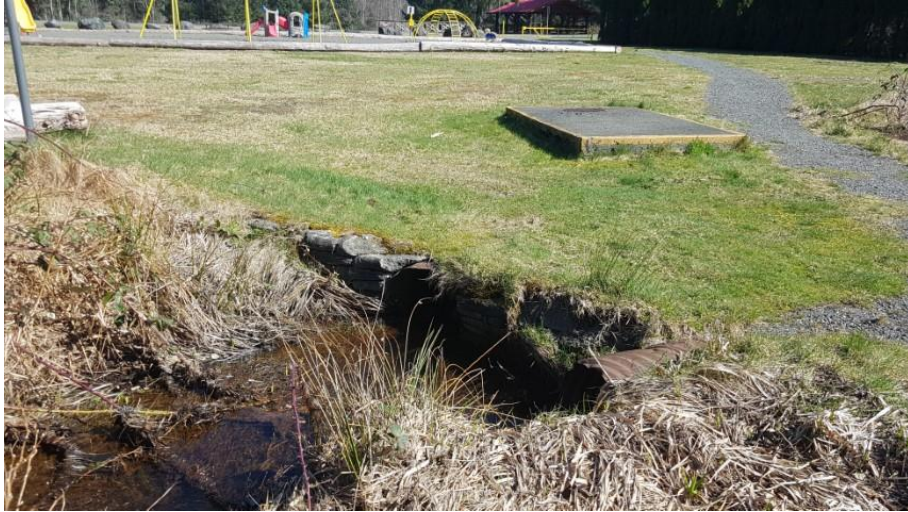
The ditch in H'Kusum Park is mostly filled with gravels and flows south into a 600 mm CSP pipe inlet at a sandbag headwall which discharges into a manhole-type structure (DMH 2 - **Photo 9**) and out to a 1200 mm diameter piped crossing under Kelsey Way that drains to the large pond between Kelsey Way and Sayward Highway. The pond outlets to the Salmon River estuary at elevation ~1.0 m via a 1050 mm MoTI culvert under Sayward Highway and Salmon River Mainline service road. We understand that a flap gate used to be installed on the outlet pipe to minimize increased water levels in the pond under large tides, however this has corroded and is no longer in place. Creek 3C also discharges to the pond and estuary as described in the next section.

Photo 9 - 600mm CSP pipe inlet to DMH 2

7. Clean outlets of the twin 900 mm CSP pipe arch culverts at Kelsey Way / Ambleside Drive and deepen the outlet ditch to the pond.
8. Upgrade DMH 2 inlet pipes to 1200 mm with new headwalls and replace DMH 2.

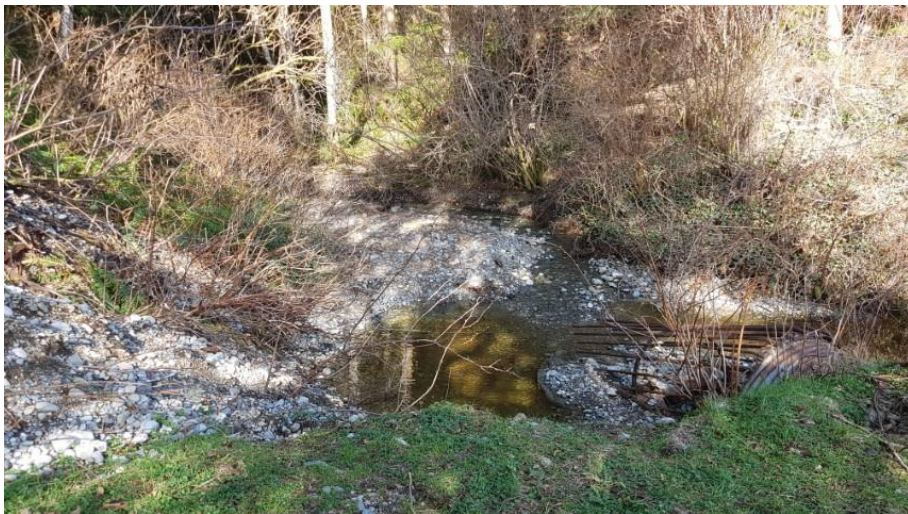
Creek 3C terminates in a pool at the west end of Dyer Drive at elevation ~25 m. Water is piped from here to H'Kusum Park via a 1200 mm diameter pipe (**Photo 11** and **Photo 13**) which runs along the rear property lines of many properties on Ambleside Drive, Sayward Heights and MacMillan Drive. No easement or SRWs are registered over the pipe route to allow the Village legal access for maintenance or replacement of the pipe. The outlet pipe in H'Kusum Park is at elevation ~4.3 m

Creek 3C is considered by the Village Public Works Manager to be the major gravel source and requires regular maintenance to remove accumulated gravels. **Photo 12** and **Photo 13** show piles of gravel that were removed from the inlet and outlet of the 1200 mm pipe between January and March 2021.

Photo 11 - Creek 3C inlet pipe/trashrack

6. If warranted (based on CCTV condition inspection) repair / replace some / all of the existing 1200 mm CSP culvert for Creek 3C. Note that this pipe trespasses through multiple private properties, so access agreements should be secured. Also refer to upgrade item **10** which recommends long term removal / abandonment of this section of pipe.

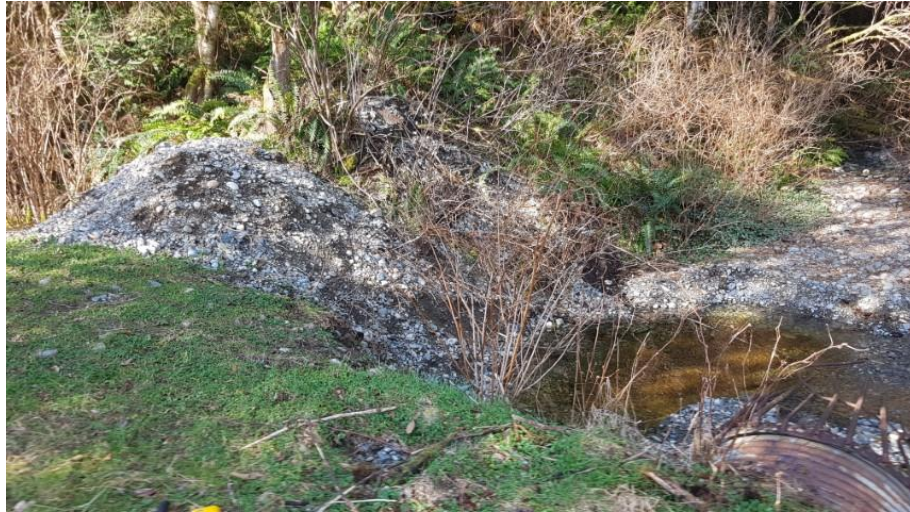
Photo 12 - Pile of dredged material from pool at Creek 3C inlet pipe

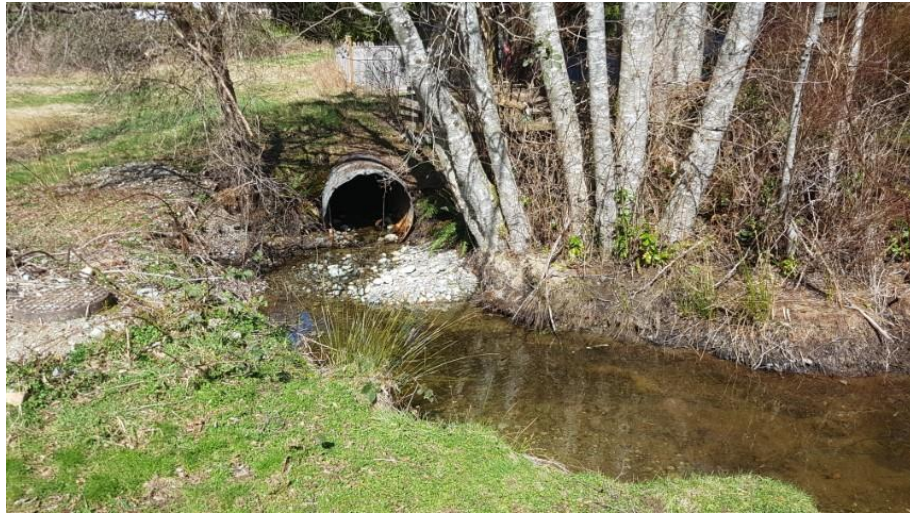
Photo 13 - Creek 3C outlet pipe at H'Kusum Park. Note pile of dredged gravels on left side of ditch.

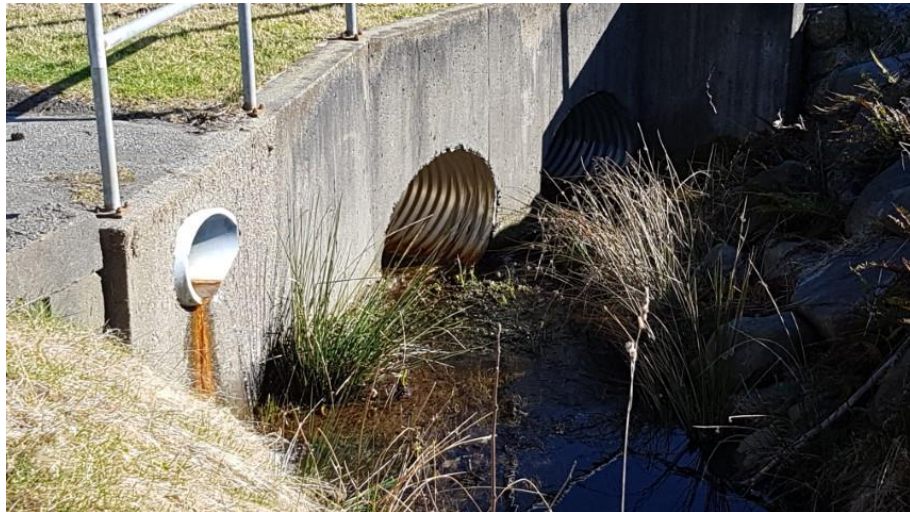
A ditch runs from this outlet to a twinned 900 mm CSP pipe arch culvert crossing under Kelsey Way (**Photo 14**) and into the pond described in **Section 2.4.2** above. The outlets of the pipe arch culvert are ~50% buried and the drainage channel into the pond was mostly filled with soils.

Photo 14 - Double 900mm CSP Pipe Arch Crossing of Kelsey Way
